UNDERWATER BRIDGE INSPECTION REPORT

STRUCTURE NO. 7065

GARDEN LAKE

DISTRICT 1 - LAKE COUNTY

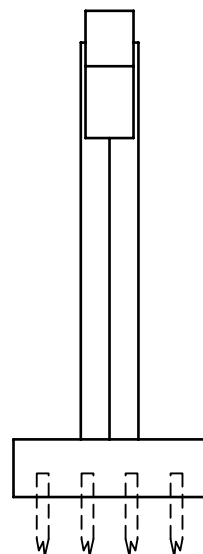
TYPICAL END VIEW OF PIERS

| <p>① The channel bottom material consisted of sandy gravel with 2 inches of probe rod penetration and scattered 1- to 3-foot-diameter riprap and 6-inch-diameter cobbles.</p> <p>② Section loss, approximately 12 inches high by 6 inches wide, with 2 inches maximum penetration.</p> <p>③ The top of a horizontal strut was observed 5.5 feet below the waterline. The channel bottom was flush with the bottom of horizontal strut on the west side of the pier, and on the east side of the pier there was a 1 foot cavity below the bottom of the horizontal strut.</p> <p>④ 1-foot-diameter log was observed on the channel bottom extending along the upstream half of the pier.</p> <p>⑤ The concrete surfaces on both piers from 6 inches above the waterline to 3 feet below the waterline exhibited up to a 1/4 inch scaling, and somewhat soft surface concrete with random popouts.</p> <p>⑥ At approximately 8.0 feet below the waterline at the center of the horizontal strut of Pier 1 a steel I-beam was observed extending out 5 feet on each side of the strut.</p> <p>⑦ A minor scour depression, 5 feet in radius by 1 foot deep, was observed at the upstream nose.</p> | <p>⑧ 6-inch-diameter and smaller timber debris was observed scattered throughout the pier.</p> <p>⑨ Heavy concentration of riprap was observed at the upstream nose.</p> |
